Index-Galena Road Asphalt Removal Mitigation - *Before and After Simulation*

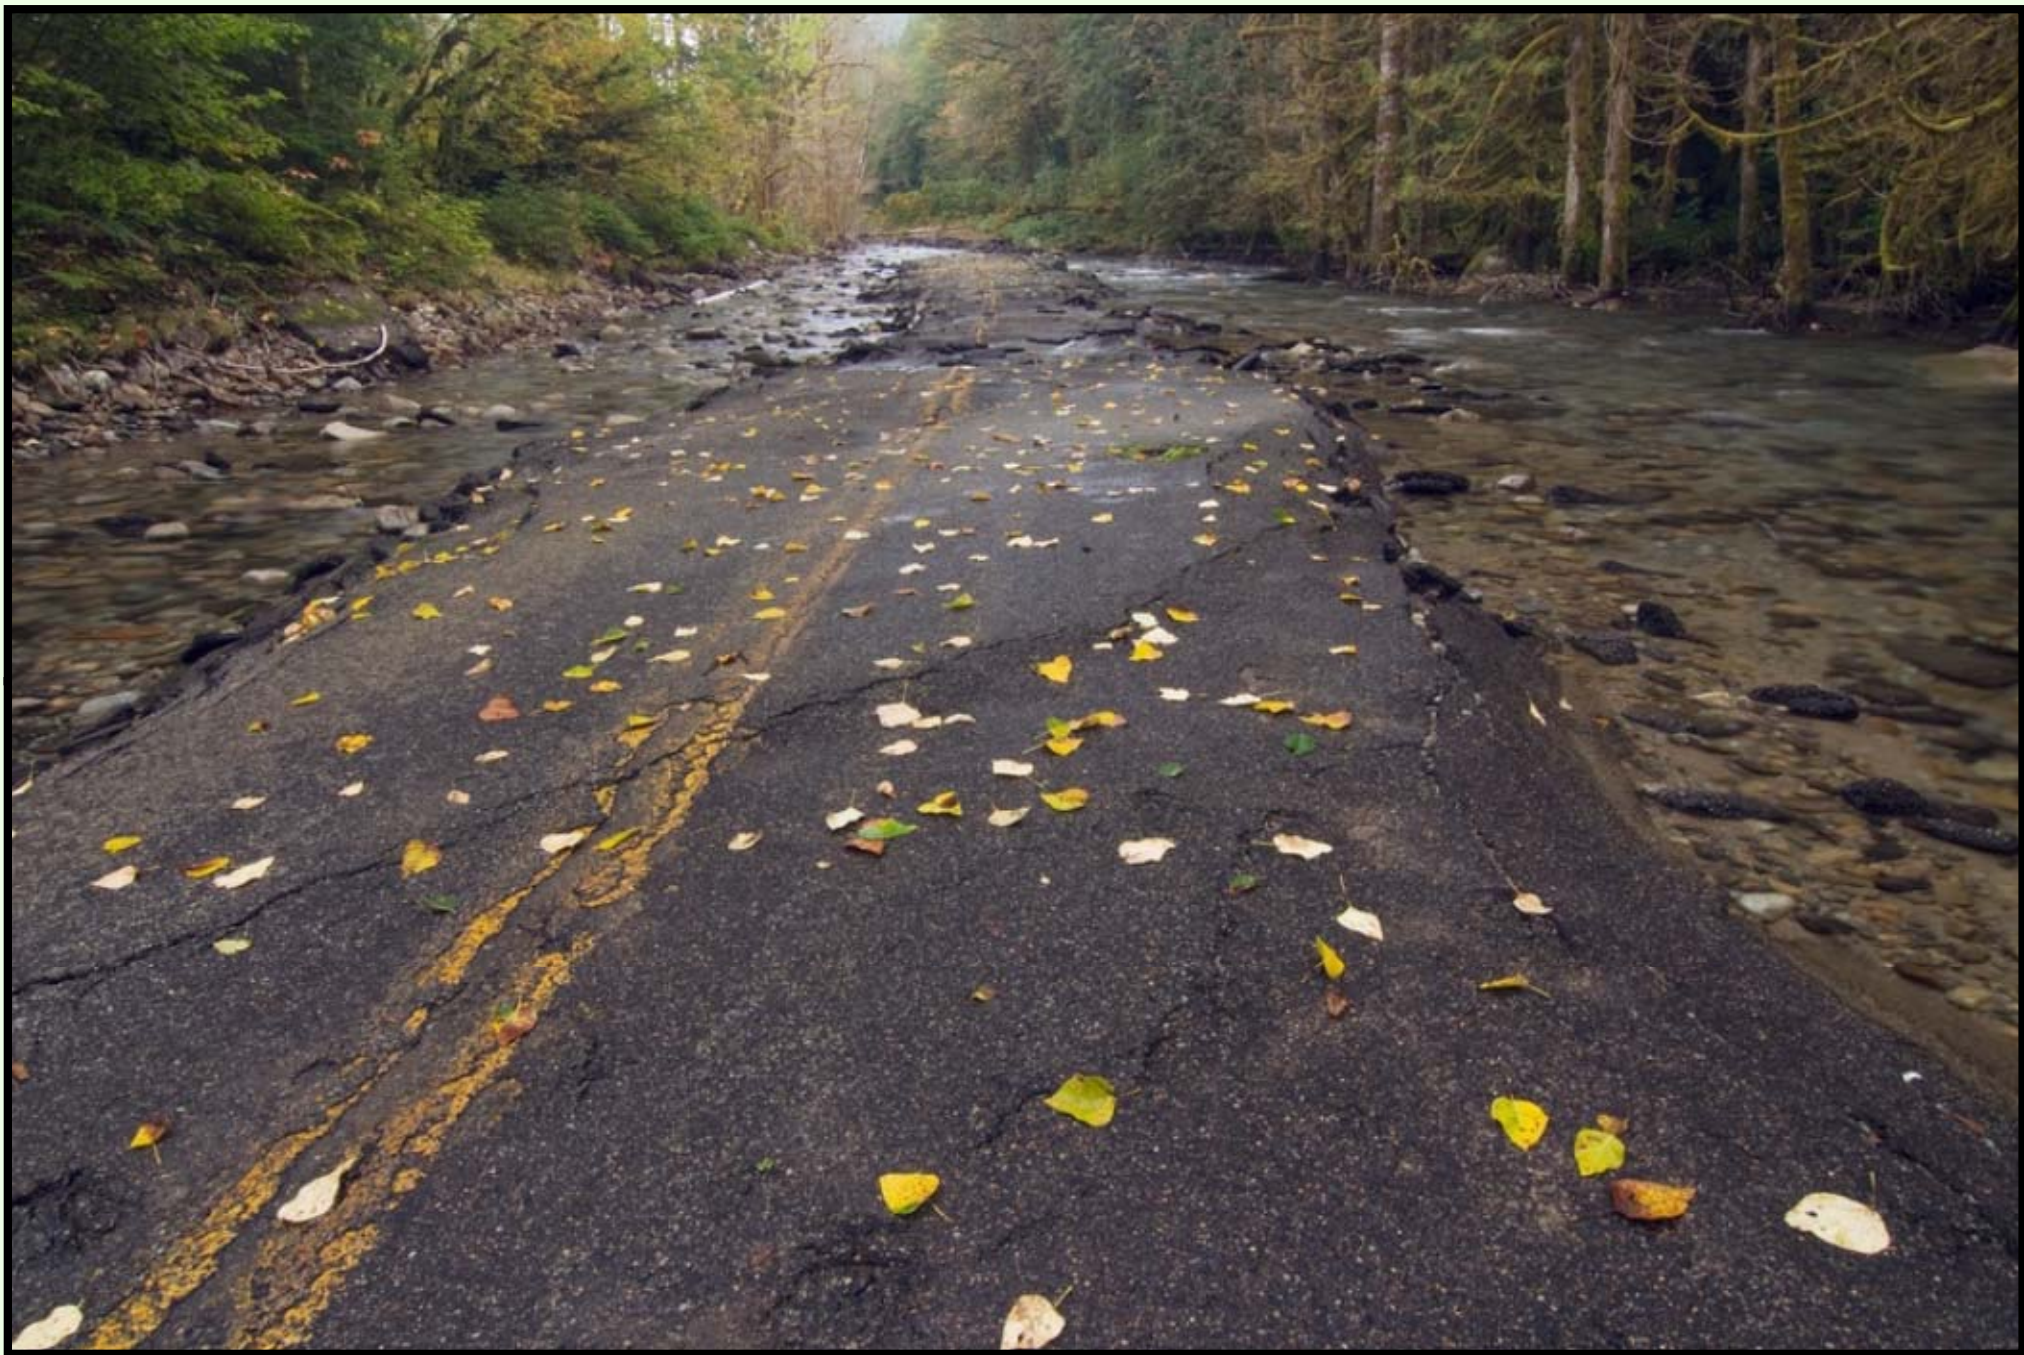
This portion of the existing Index-Galena Road alignment is located upstream from Milepost 6.4. It is an "island" of intact asphalt surrounded by the newly formed side channel that was created by the November 2006 high flows. A temporary access road would need to be constructed to provide equipment access during construction to enable asphalt removal and site restoration activity.

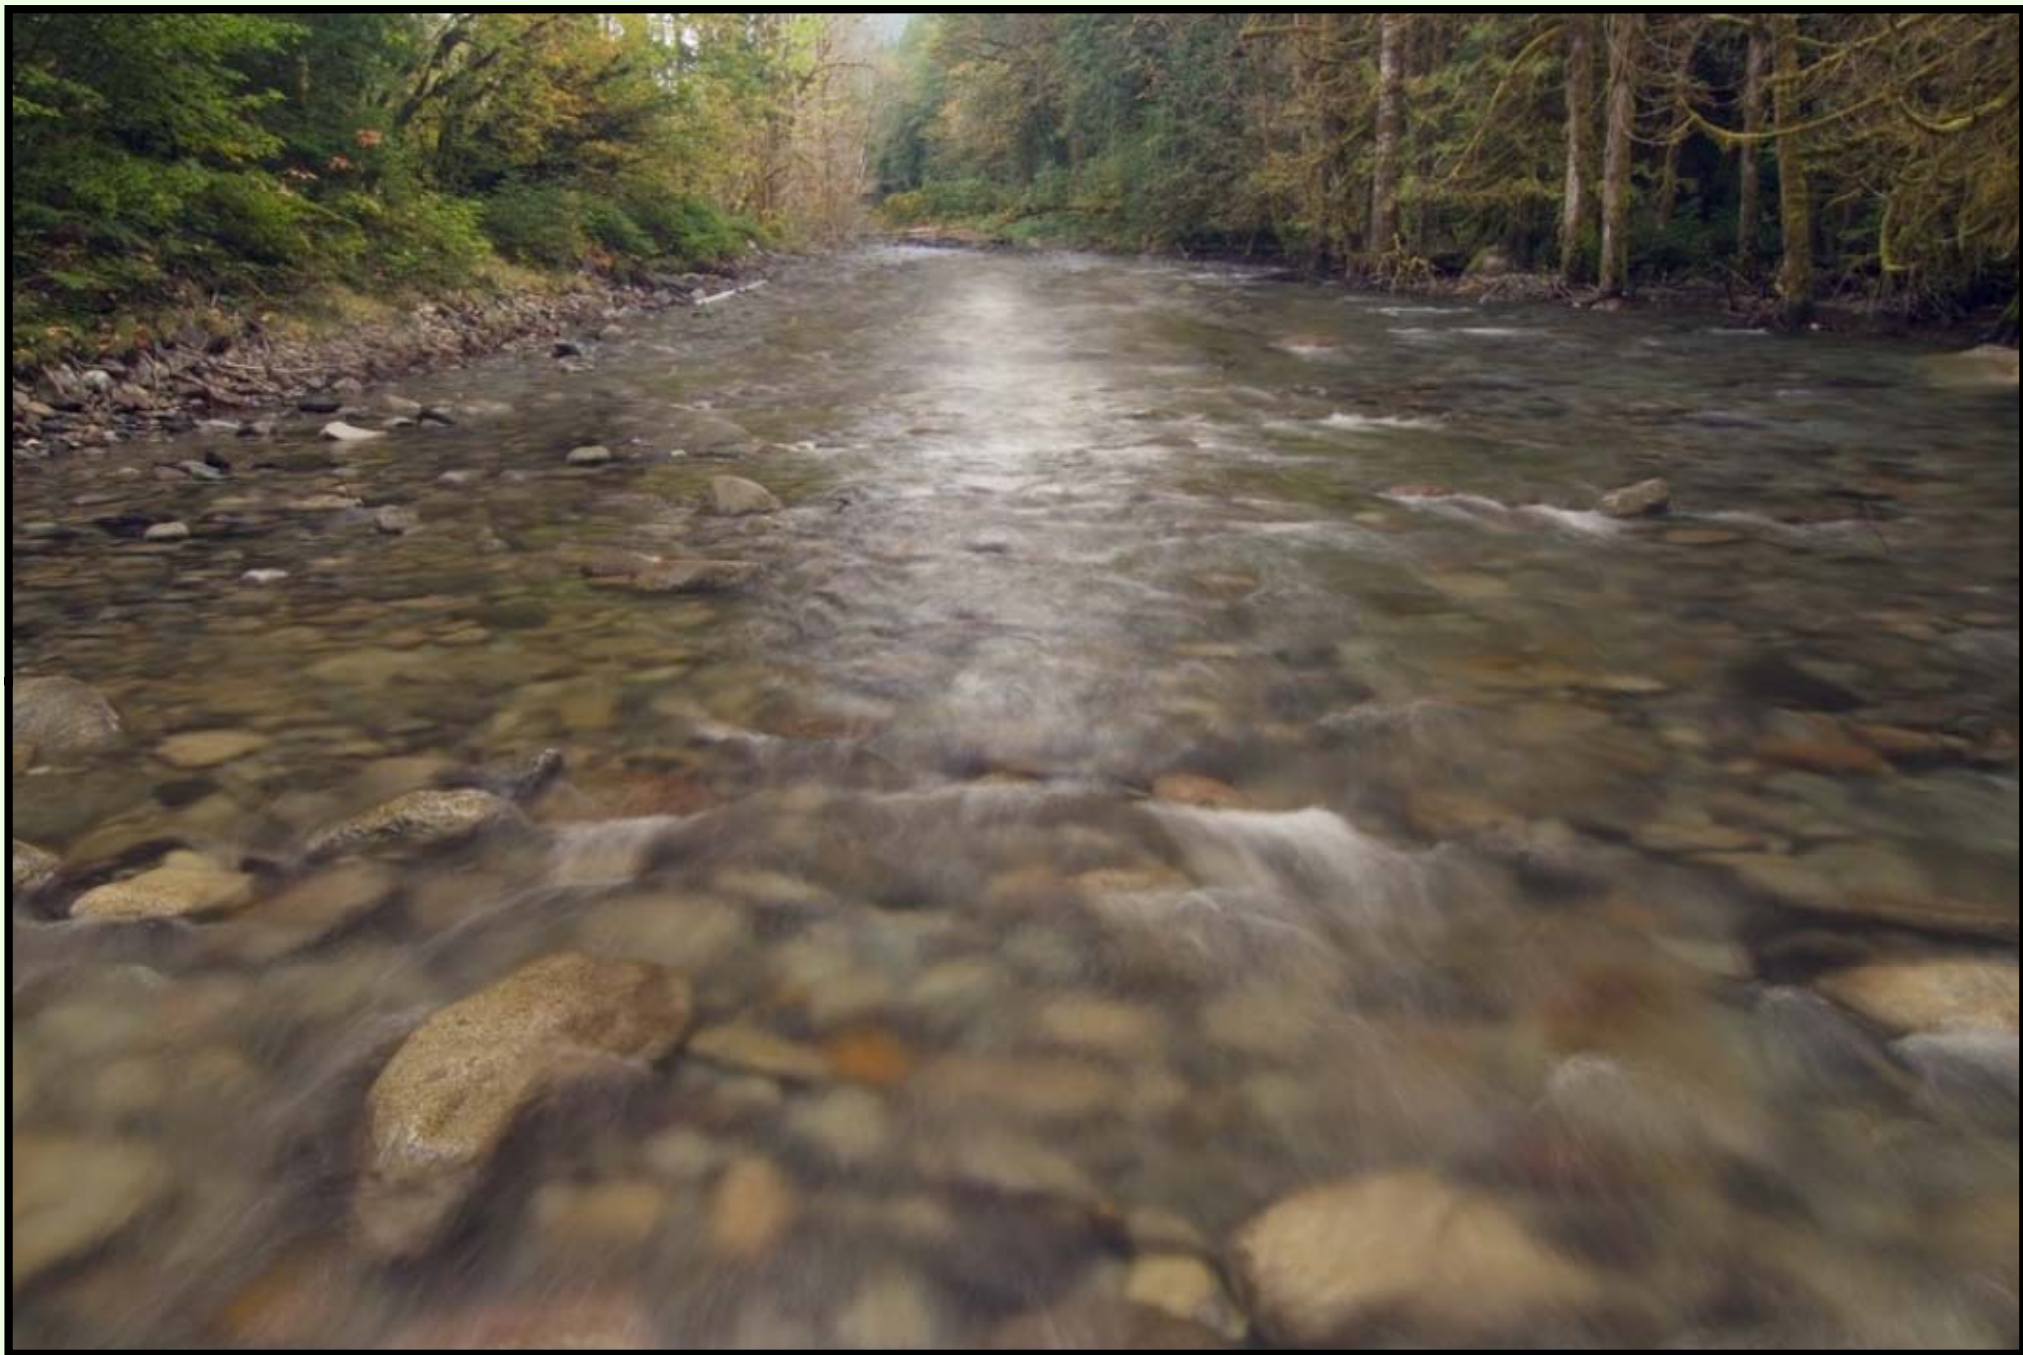
This photo simulation shows how the stream could potentially look after asphalt removal restores the natural stream conditions. While the future restored channel would likely appear differently, this simulation provides a sense of how a restored channel would look.

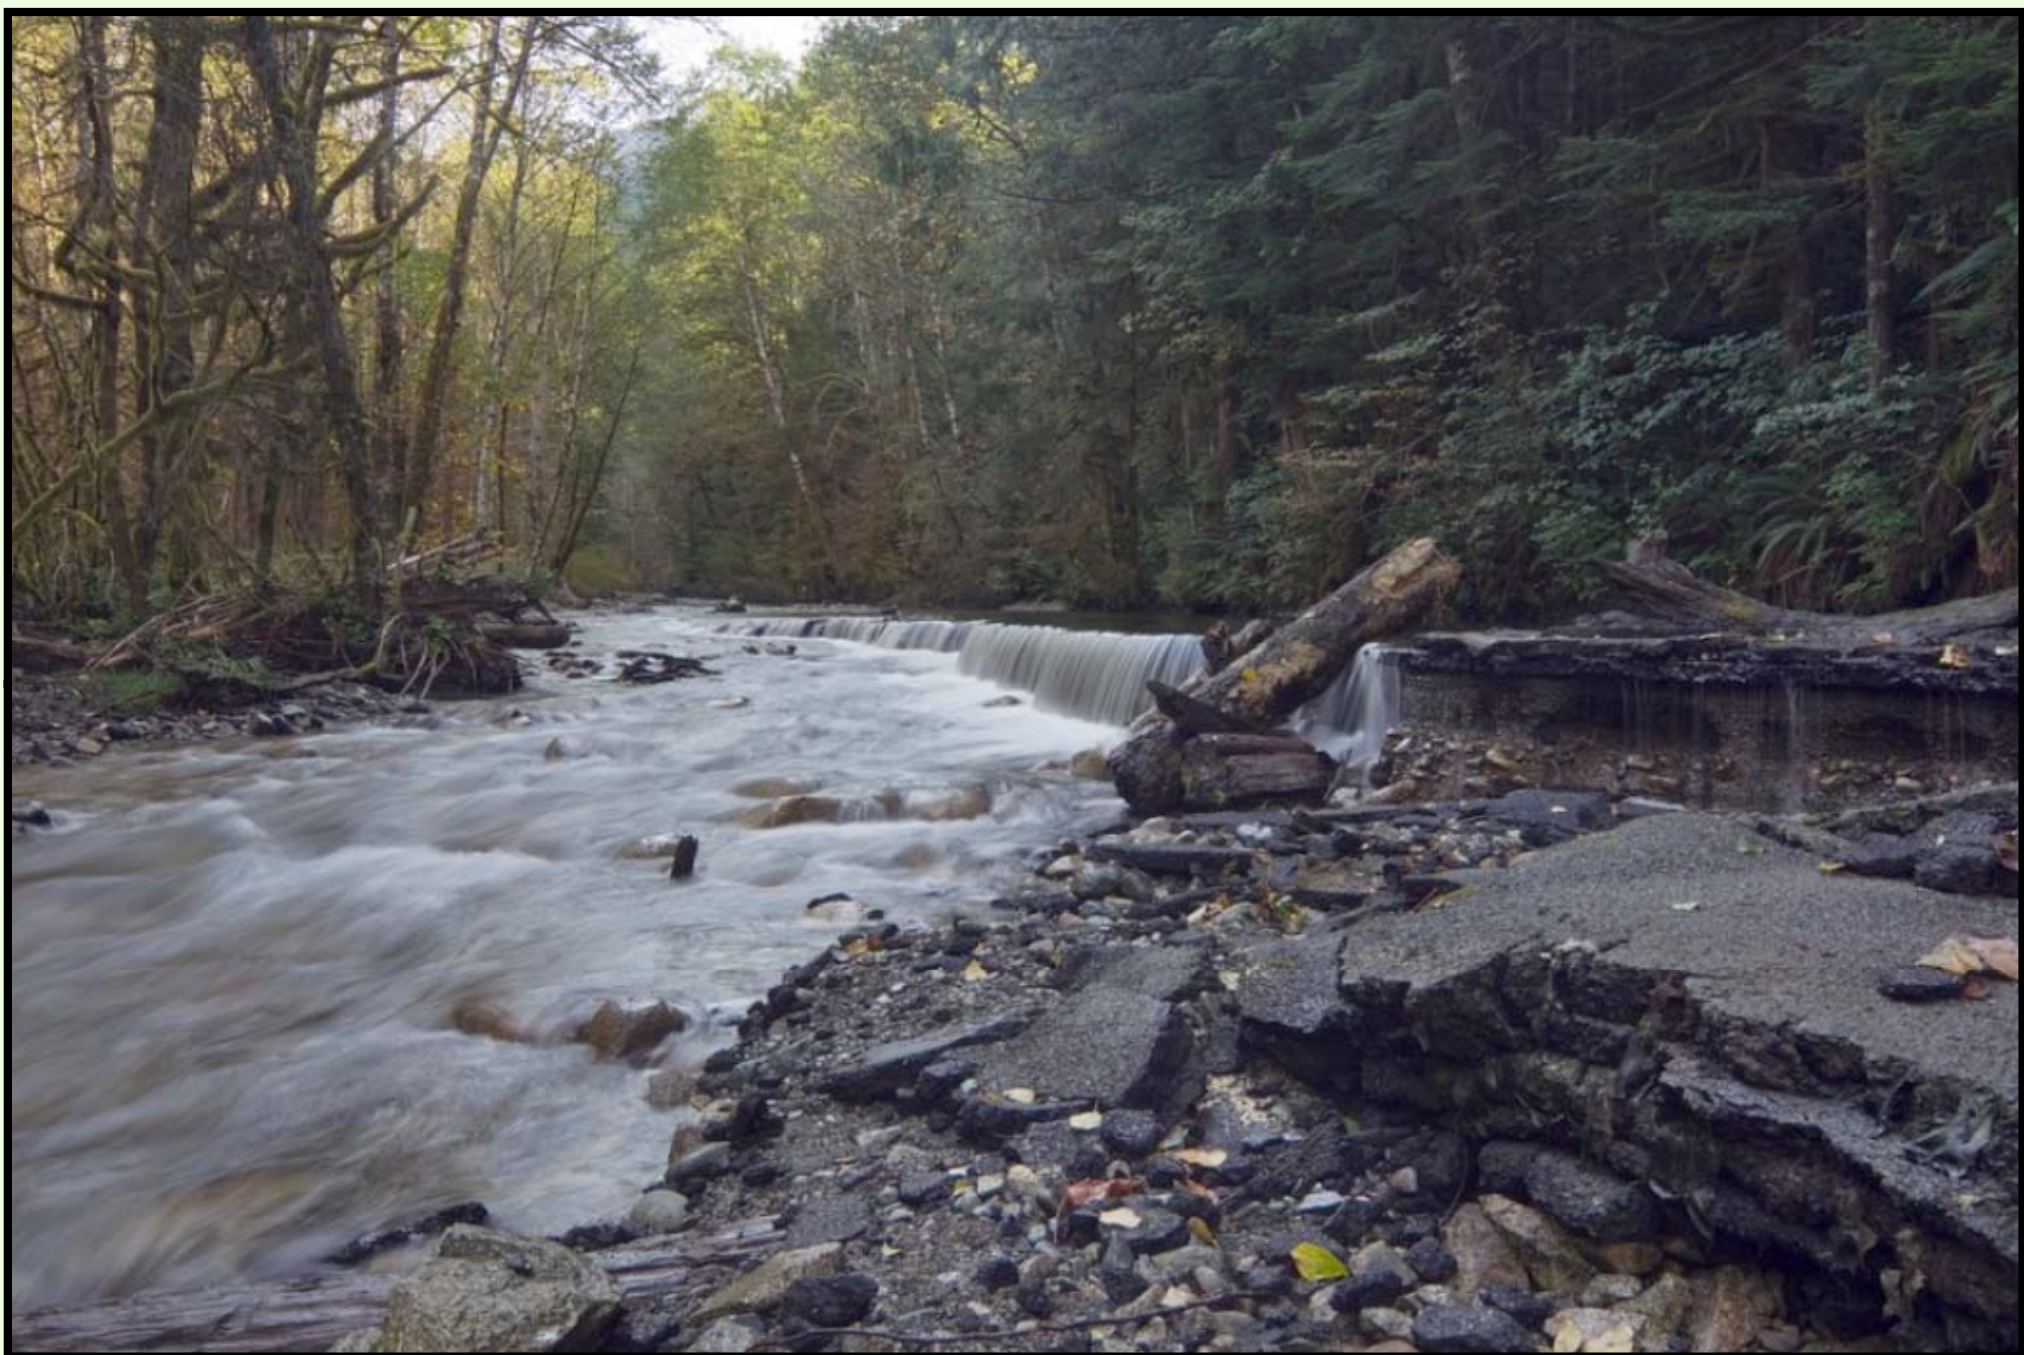
This damage site is located at the Milepost 6.4 washout that severs roadway connectivity to upstream areas. This area would be restored to more natural conditions with asphalt removal.

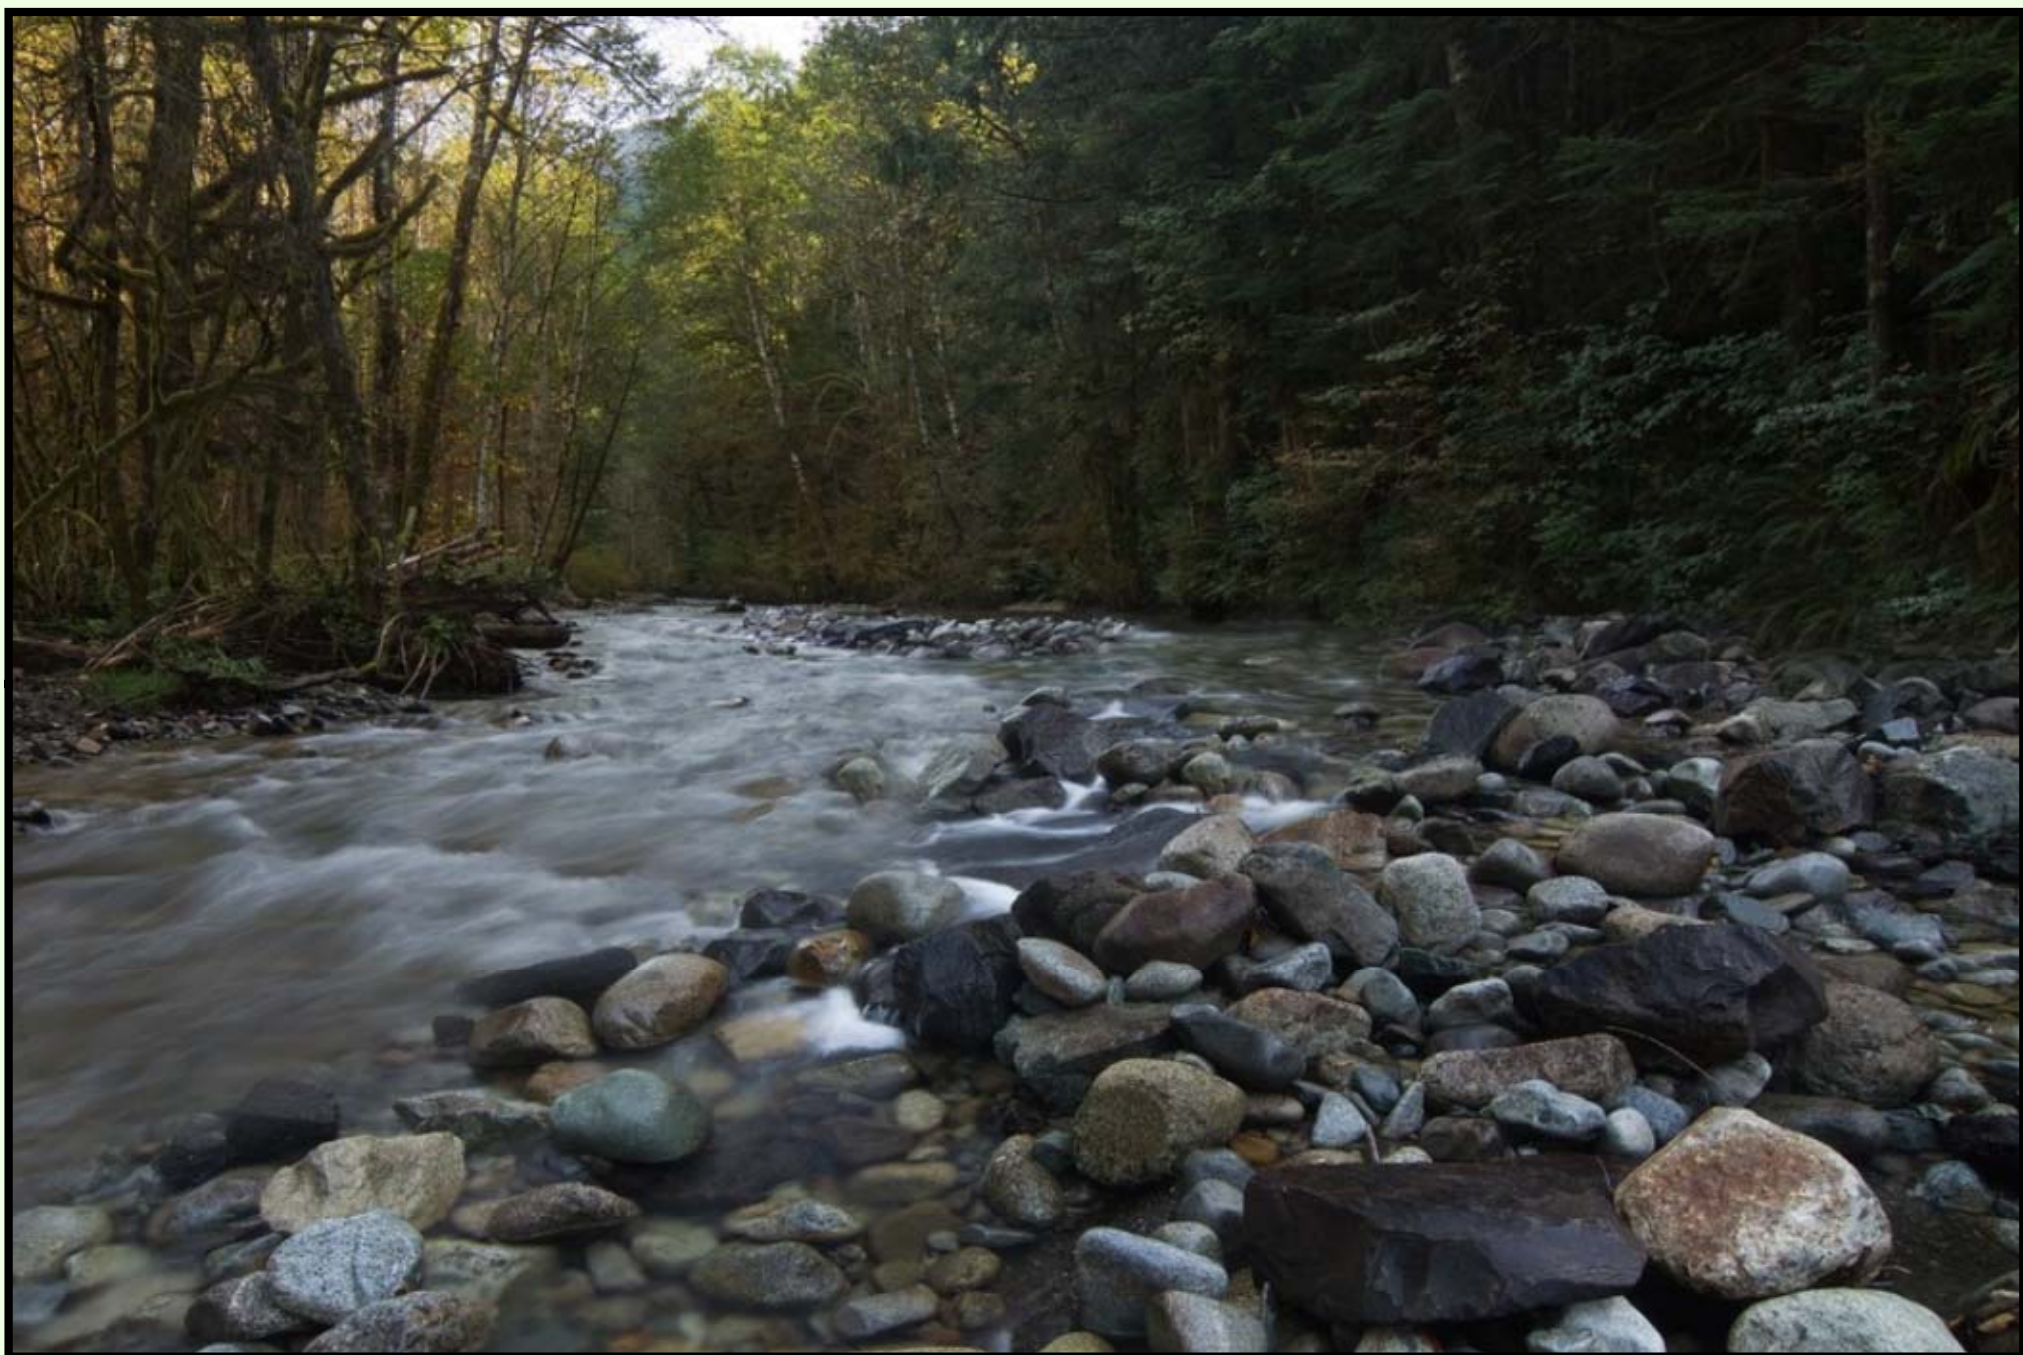
This photo simulation shows how the Milepost 6.4 washout could appear once asphalt has been removed. While future conditions would not match this image exactly, it demonstrates that a more natural appearance would result from restoration.

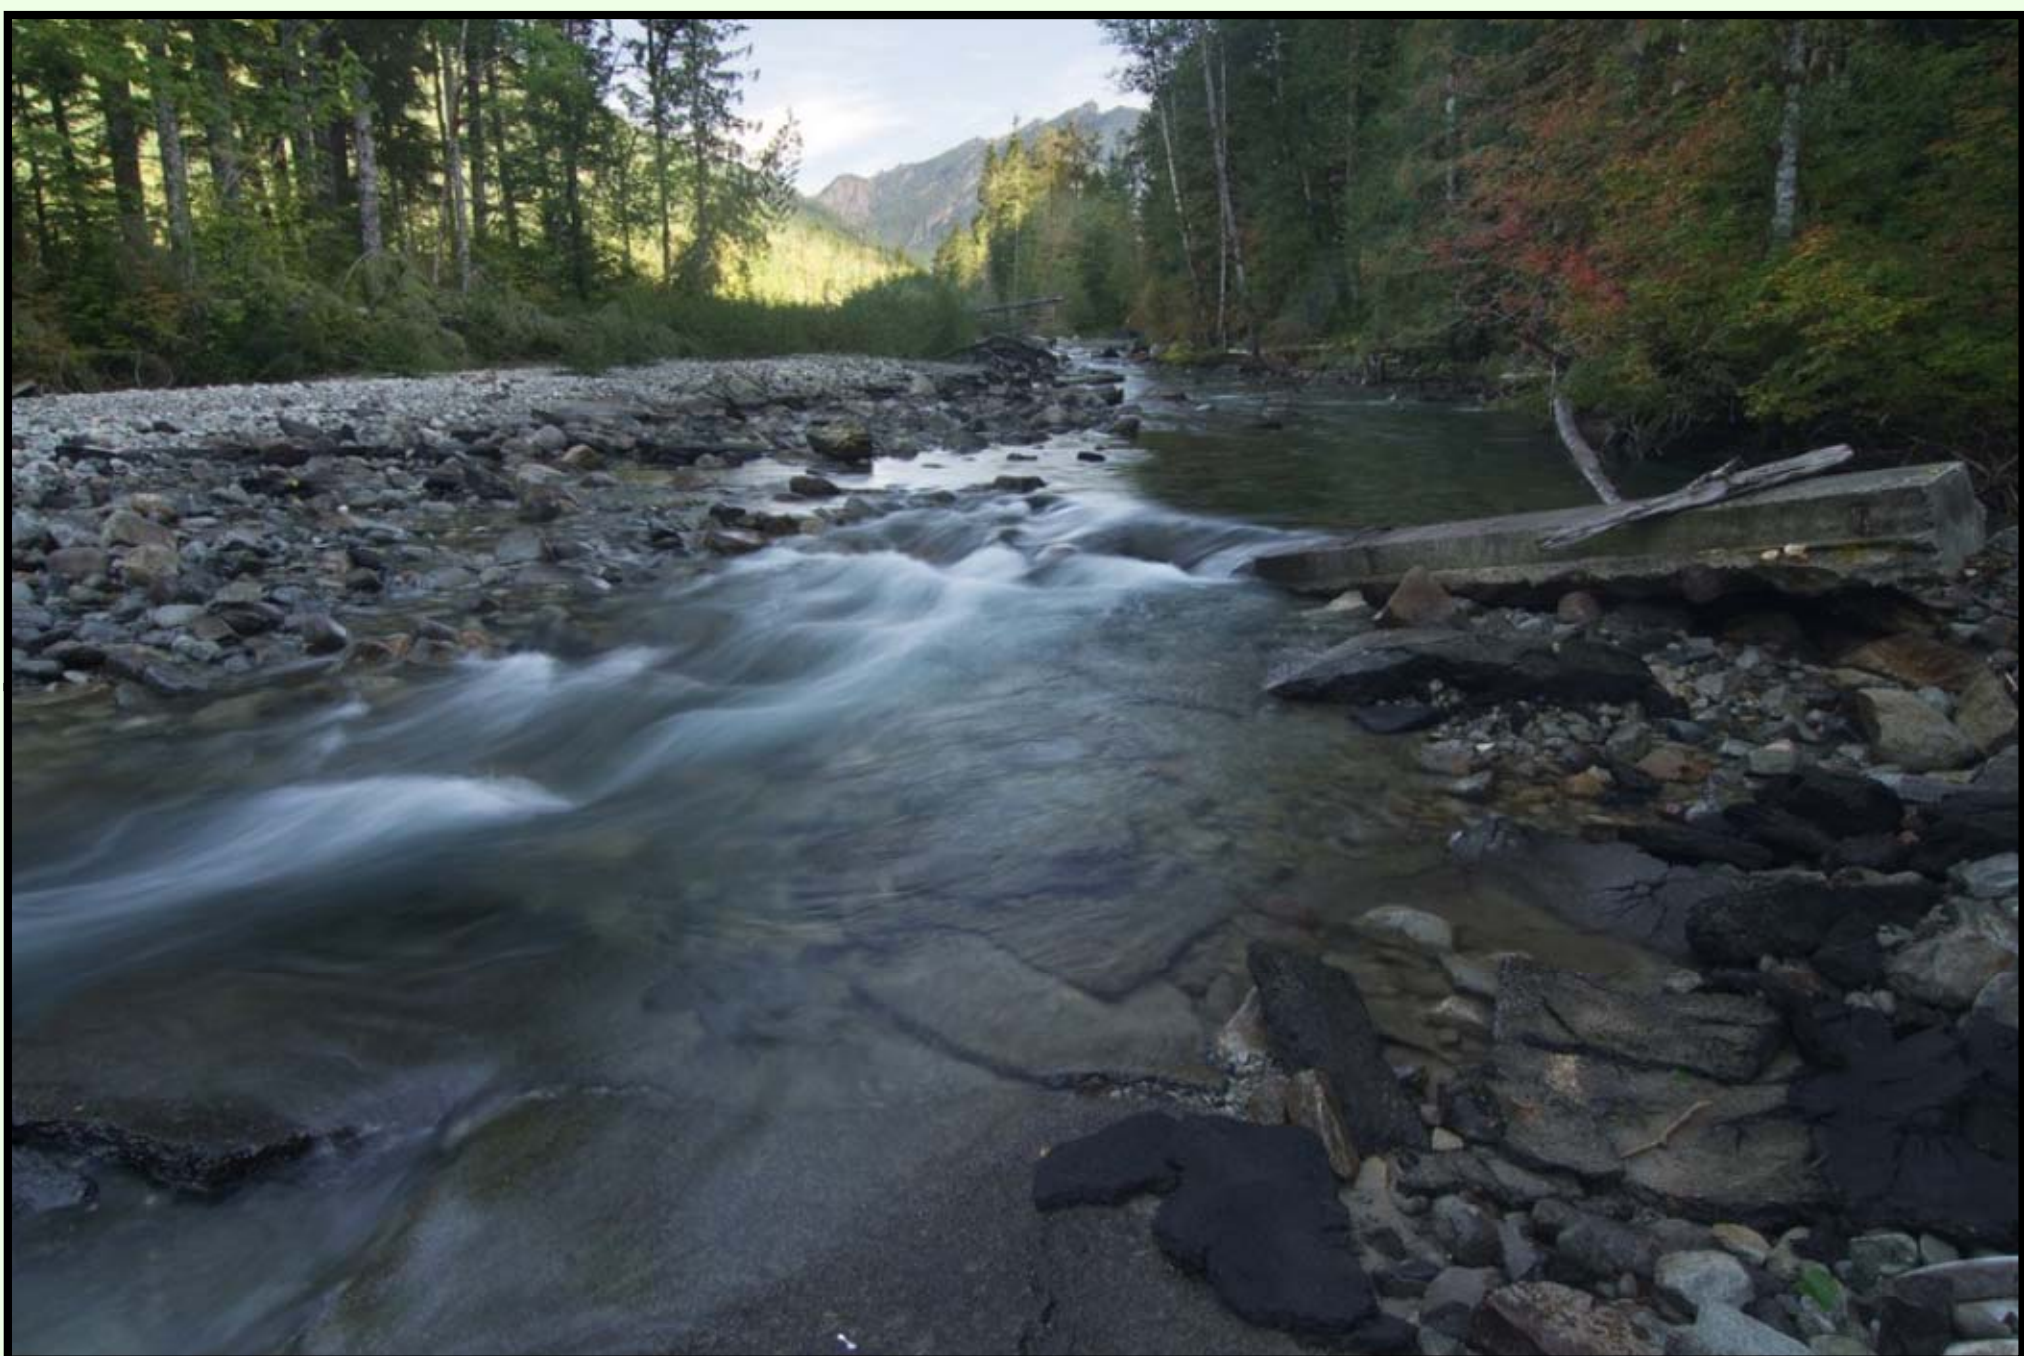
This photo shows the area near Milepost 6.7 where the upstream washout is located between Milepost 6.9 and Milepost 6.7. There are extensive areas of asphalt, concrete, & other roadway related debris. A temporary stream crossing will be required during construction to remove material from the opposite bank of the side channel.

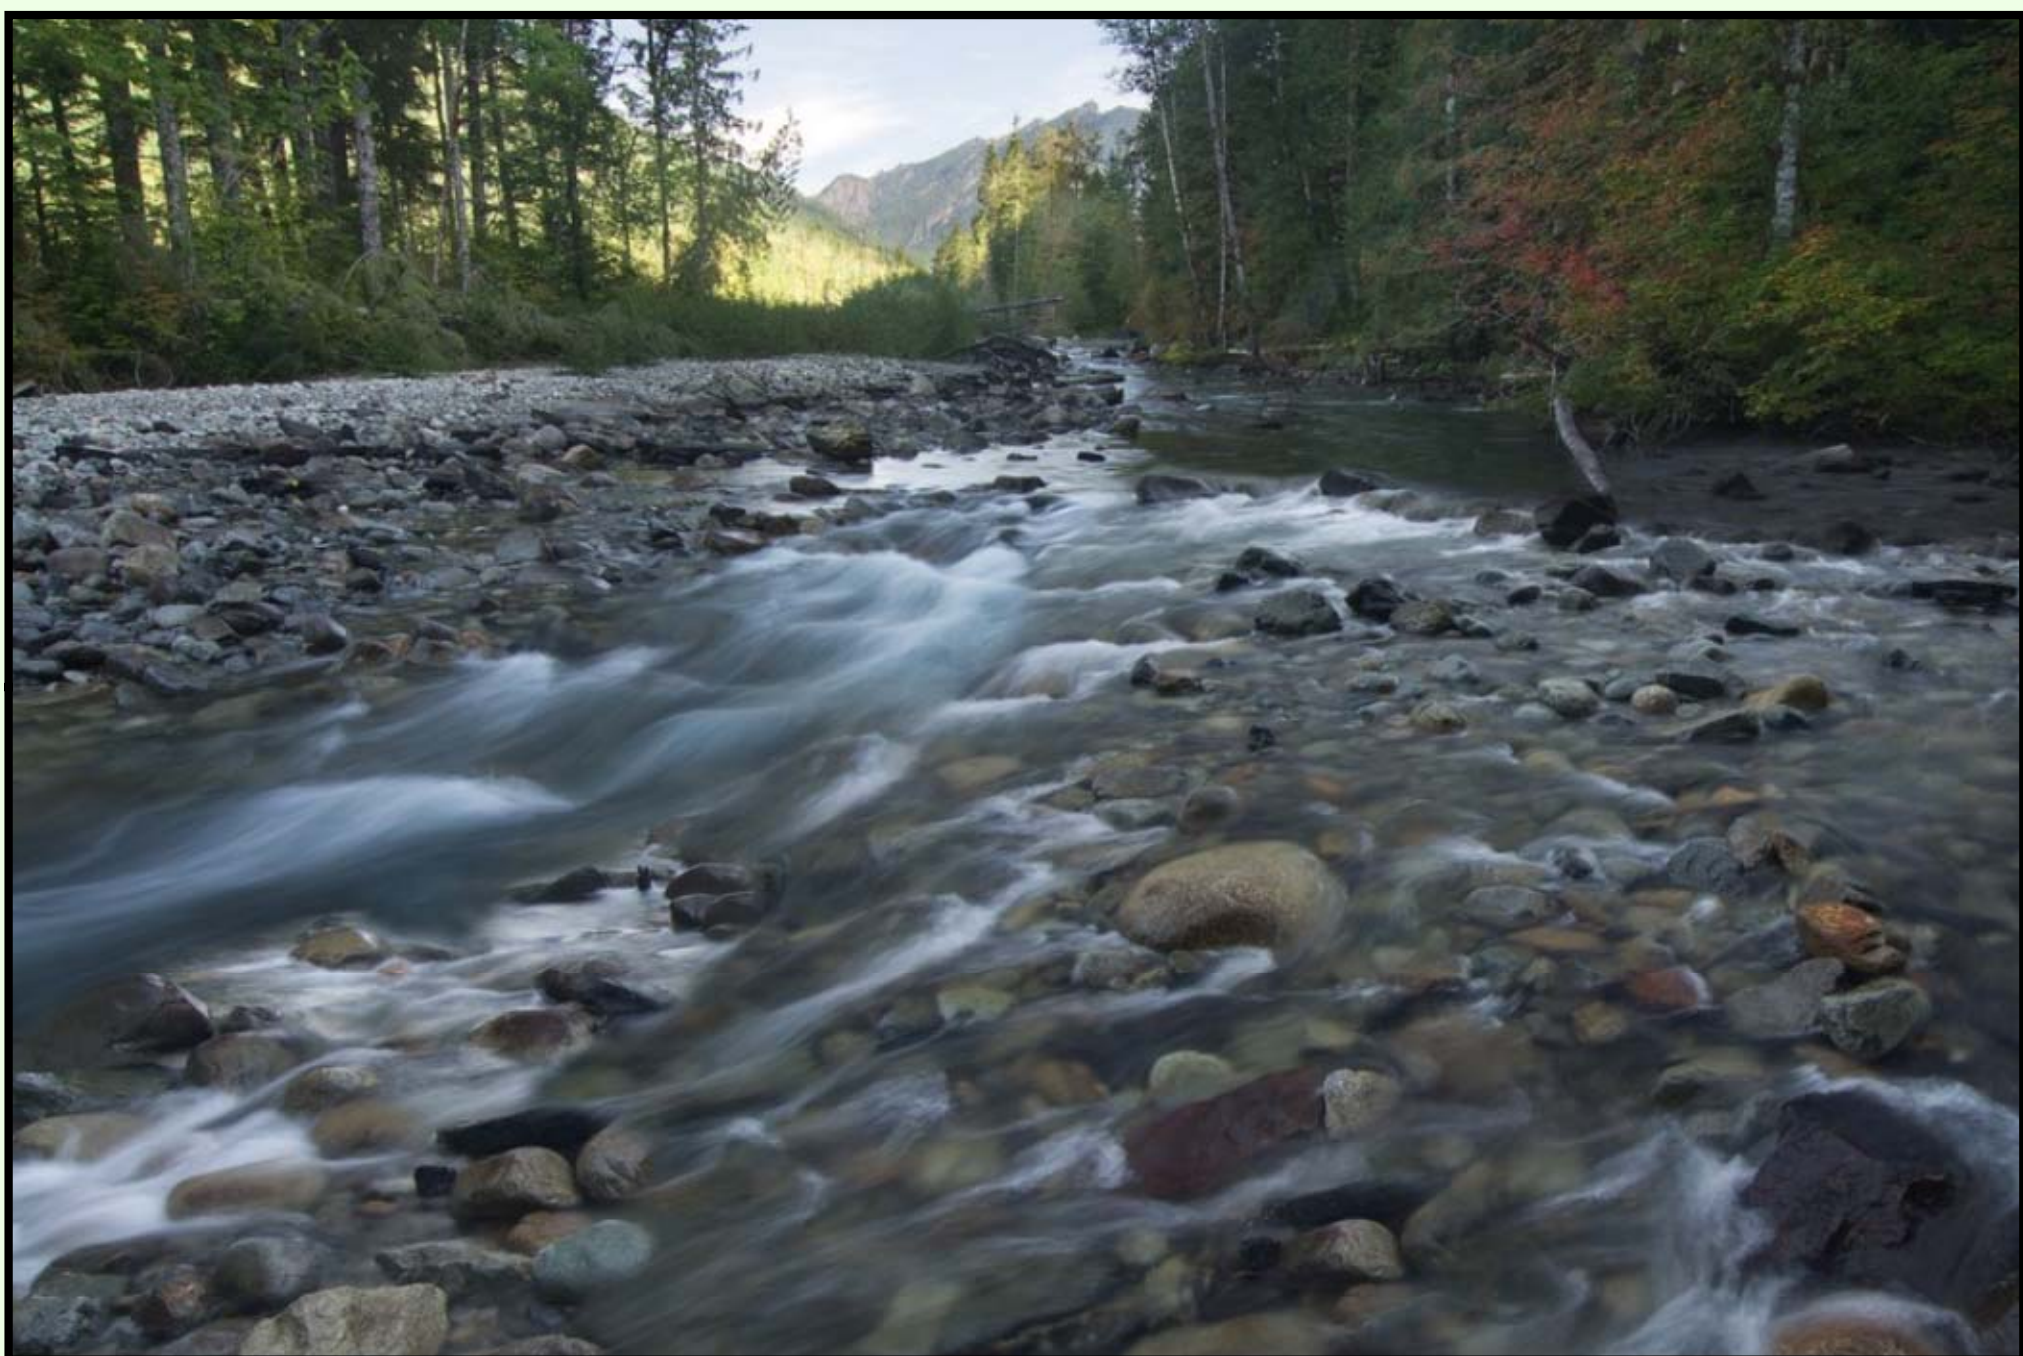
This simulation shows how Milepost 6.7 could look once restored to more natural stream conditions. This portion of the project area provides scenic vistas both up and down the North Fork Skykomish River valley.
